CHAPTER 2: REACH DESCRIPTIONS

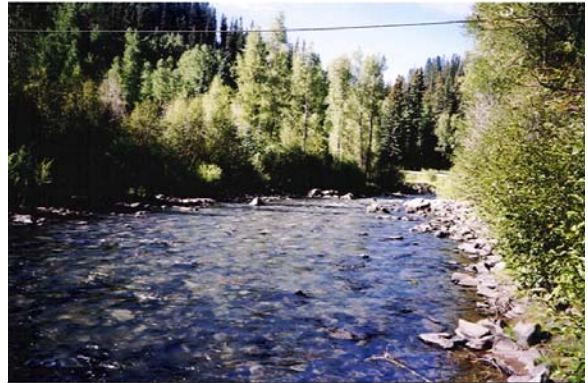
Figure 2-1: Dolores River view downstream of the bridge at the County line. Note the dense native vegetation along the channel.

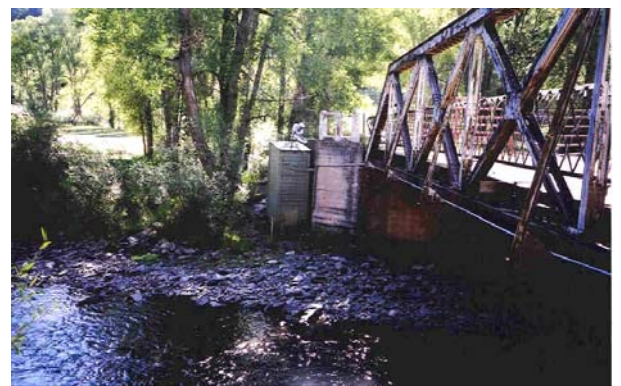
Figure 2-2: USGS Gage at the Montelores Bridge downstream of Rico at the County Line.

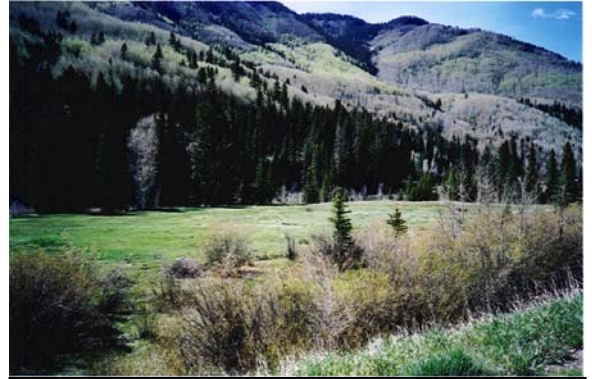
This reach may be significantly impacted by the construction of the wastewater treatment plant. It is possible that the plant may encroach into the floodplain. Stabilizing vegetation may be removed as a part of the construction. Channel improvements may be needed to protect the plant from flooding and channel instability.

Figure 2-3: This riverside pasture area could be the site of the future wastewater treatment plant serving the Town of Rico.

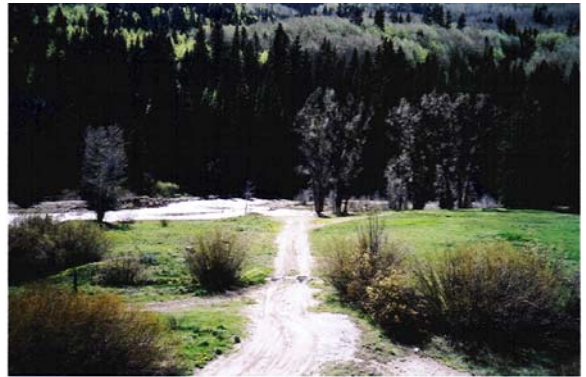
This 0.3-mile reach, from Station 180+00 to 196+50, is the lower area of the Town of Rico. This river reach has an average slope of 1.30%, from elevation 8648 to 8670 feet. This reach has been disturbed by mine tailings, roads and development. Encroachment into the floodplain, construction of berms and levees, and destruction of riparian vegetation has destabilized the reach of the river, and there is evidence of lateral channel migration during floods. Bare cobble bars are evidence of channel erosion and deposition zones.

Figure 2-4: Access road to the river between Reaches D1 and D2. Manmade impacts are evident in this reach of the river.

The most significant impact results from the mine tailings piles from the Rico Boy and Santa Cruz mines. Although engineered caps have been constructed on these piles, they encroach into the floodplain causing more stress on the channel bed and banks during floods. Restoration may be helpful in this reach to remove berms and other encroachments, restore vegetation along the channel banks and add boulder clusters for trout habitat.

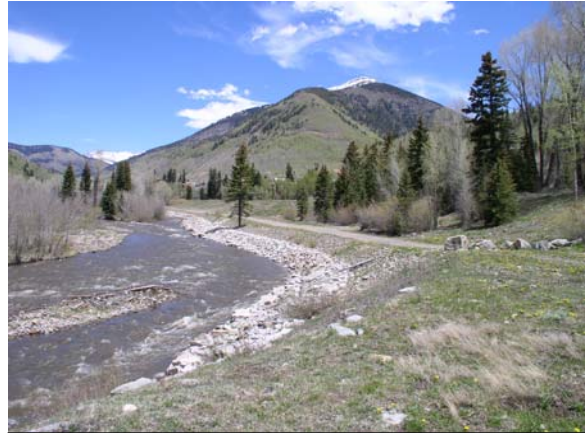
Figure 2-5: This section of the channel is not natural and has been “engineered” to be stable during a flood event. However, this alteration often propagates instability downstream.

The most significant impact is the encroachment into the historic river corridor from the Columbia Tailings Cap. This site was reclaimed under a Voluntary Clean-up program, however, the cap has not been effective at eliminating mine seeps into the river. The tailings, cap and stabilizing bank riprap have encroached into the floodplain, causing more stress on the channel bed and banks during floods. This encroachment and lack of vegetation deflects the river’s energy to the opposite bank and causes the river to become more unstable. Restoration would be helpful in this reach to push the tailings piles and other encroachments outside the historic floodplain and to restore vegetation along the channel banks.

Restoration would be helpful in this reach to push the tailings piles and other encroachments outside the historic floodplain and to restore vegetation along the channel banks.

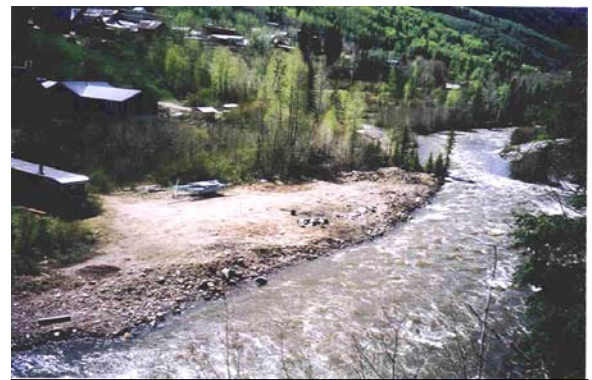
This quarter mile reach, from Iron Draw on the west bank to Silver Creek on the east bank (Station 230+00 to 244+00), is a uniquely steep section of the Dolores River. Silver Creek has created an alluvial fan at its outfall into the Dolores River, which has steepened this section of the river. Silver Creek is a very powerful drainageway during flooding and has carried and deposited significant amount of material at the confluence. Therefore, the Dolores River is significantly steeper (average slope of 3.64%) where it is flowing through this depositional landform. Other factors affecting stability through this reach of the Dolores River is the residential development on the east bank. A steep slope coupled with a loss of riparian vegetation has made this an unstable section of river. Bank erosion is evident in this area.

Figure 2-6: All stabilizing riparian vegetation has been removed in front of this development.

Several structures have been constructed within the 100-year floodplain in this reach. These buildings are subject to inherent flood hazards. To mitigate the hazard, the buildings can either be relocated, or hard controls may be required along the river to anchor the channel in its current alignment.

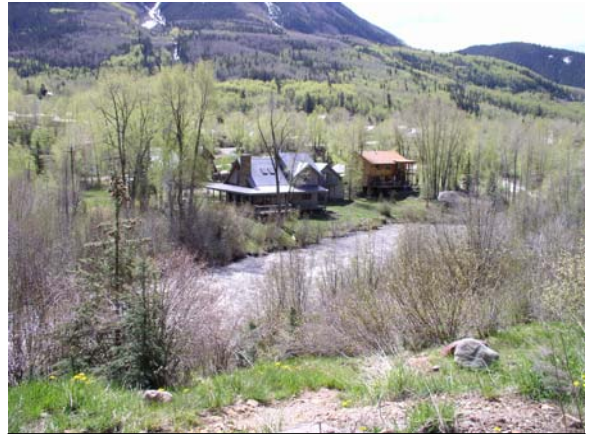
Figure 2-7: Several residential structures have been constructed within the river floodplain.

Residential structures have been constructed within the 100-year floodplain in this reach. These buildings are subject to inherent flood hazards. To mitigate the hazard, the buildings can either be relocated, or hard controls may be required along the river to anchor the channel in its current alignment.

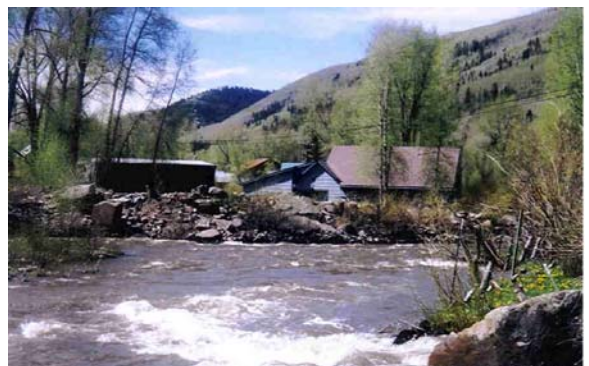
This quarter mile reach, from Silver Creek to the Highway 145 Bridge (Station 244+00 to 257+50), contains some instability problems and some development pressure. The alluvial fan created by Silver Creek and located in the reach immediately downstream, has flattened this section of the Dolores River upstream compared with both upstream and downstream sections. The average channel slope through this reach is 1.88%, which is steep for most rivers, but comparatively on the upper Dolores River is a milder slope. This flattening of the channel bed reduces stream power and causes deposition of bed load cobbles. Deposition causes the river to shift laterally during a flood, which makes the river unstable. However, man-made berms to protect structures in the floodplain have been constructed in an effort to limit channel migration and minimize overbank flooding. These berms remove stabilizing riparian vegetation and concentrate the river's stream power into the channel, further exacerbating channel instability.

Figure 2-8: Broken concrete, rubble and dirt have been bermed up to protect these houses from flood hazards. Berms adjacent to the river destroy riparian vegetation and concentrate stream power on the channel during a flood thereby reducing stability.

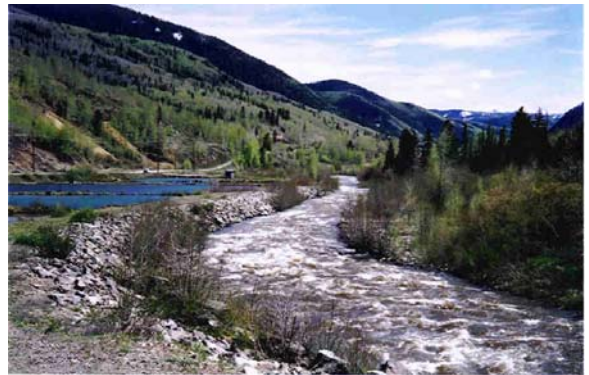
Encroachment of the ponds and the stabilizing bank riprap into the historic river floodplain corridor is the most significant impact to this reach. This encroachment causes more stress on the channel bed and banks during floods. The lack of vegetation channelizes the river giving it the characteristic of a chute rather than a natural stream channel with wetland pockets. Restoration of a portion of the historic floodplain by minimizing the number of settling ponds would improve the natural functions of the river corridor.

Figure 2-9: View downstream toward Rico along the Dolores River. The St. Louis settling ponds (left) are isolated from the river by lining the channel bank with riprap.

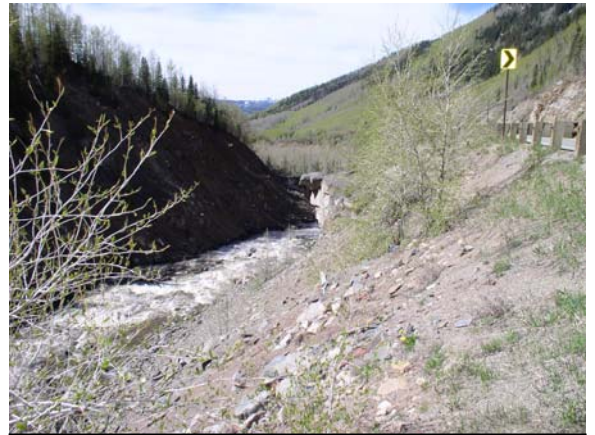
The area is significant to the Town of Rico because flood hydraulics will mobilize the cobbles and bed material in the channel. Therefore, there should be an area below the “Chutes” to calm the water before it reaches town. Otherwise, deposition, erosion and lateral channel migration will occur adjacent to development, putting structures at risk to river hazards.

Figure 2-10: The Chutes above the Town of Rico mobilize cobbles and bed material, which deposit in the flatter areas around town.

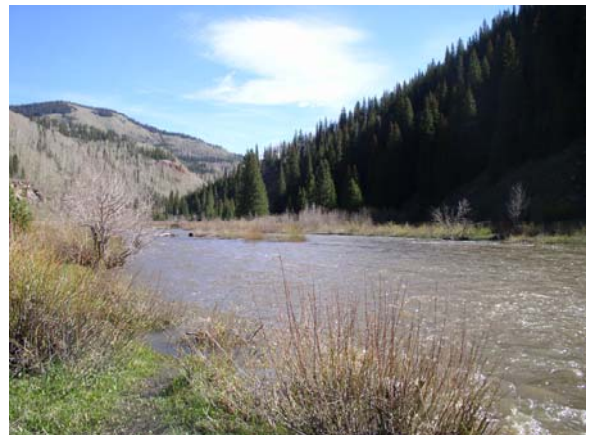
Figure 2-11: This natural section of river two miles above Rico is a pristine reach. Water quality is generally good and wetlands are abundant.

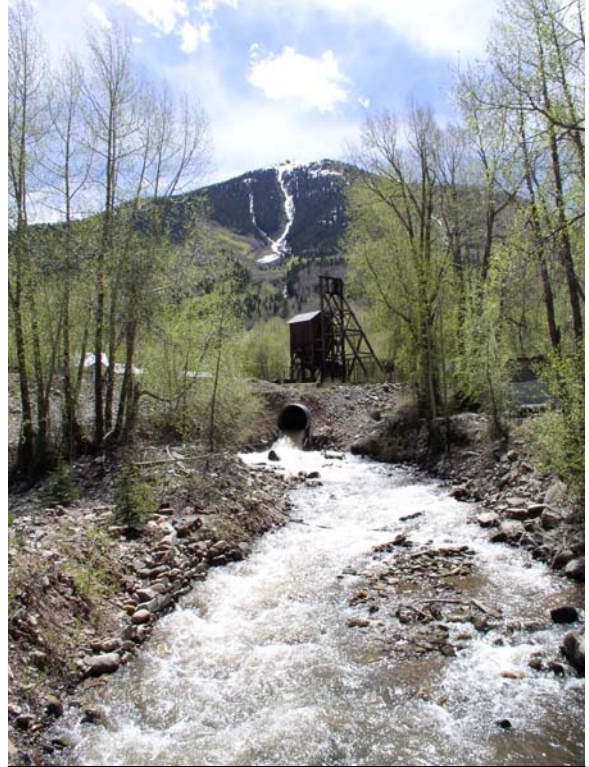
Silver Creek is highly unstable due to the high and flooding potential. Development has encroached into the floodplain which increases the flood hazard potential of the adjacent buildings. Berms have been constructed to control flooding, but these berms are not FEMA compliant and may not withstand a significant flood.

Figure 2-12: Silver Creek is a roaring creek that can move a tremendous amount of rock , mud and debris during a flood event.
